Natural Water Quality
in Butano Formation Wells

2004 Groundwater Management Annual Report
Scotts Valley Water District
April 2005

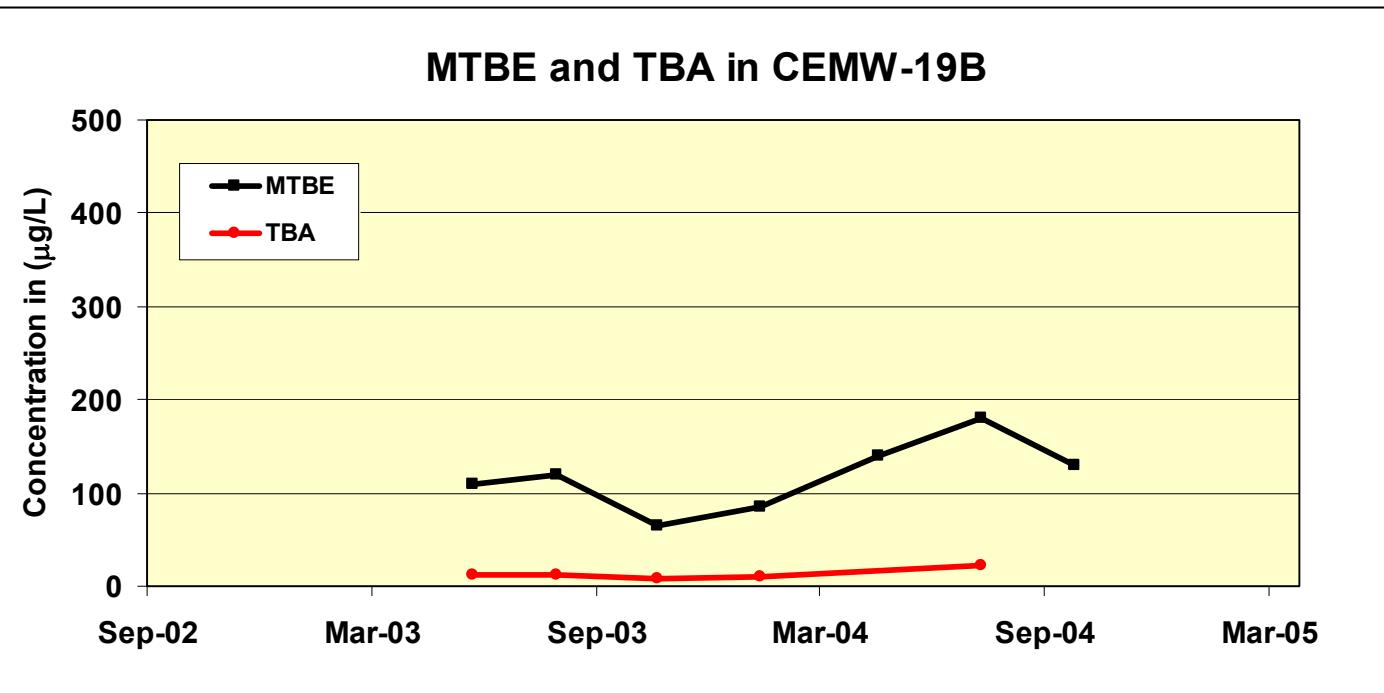
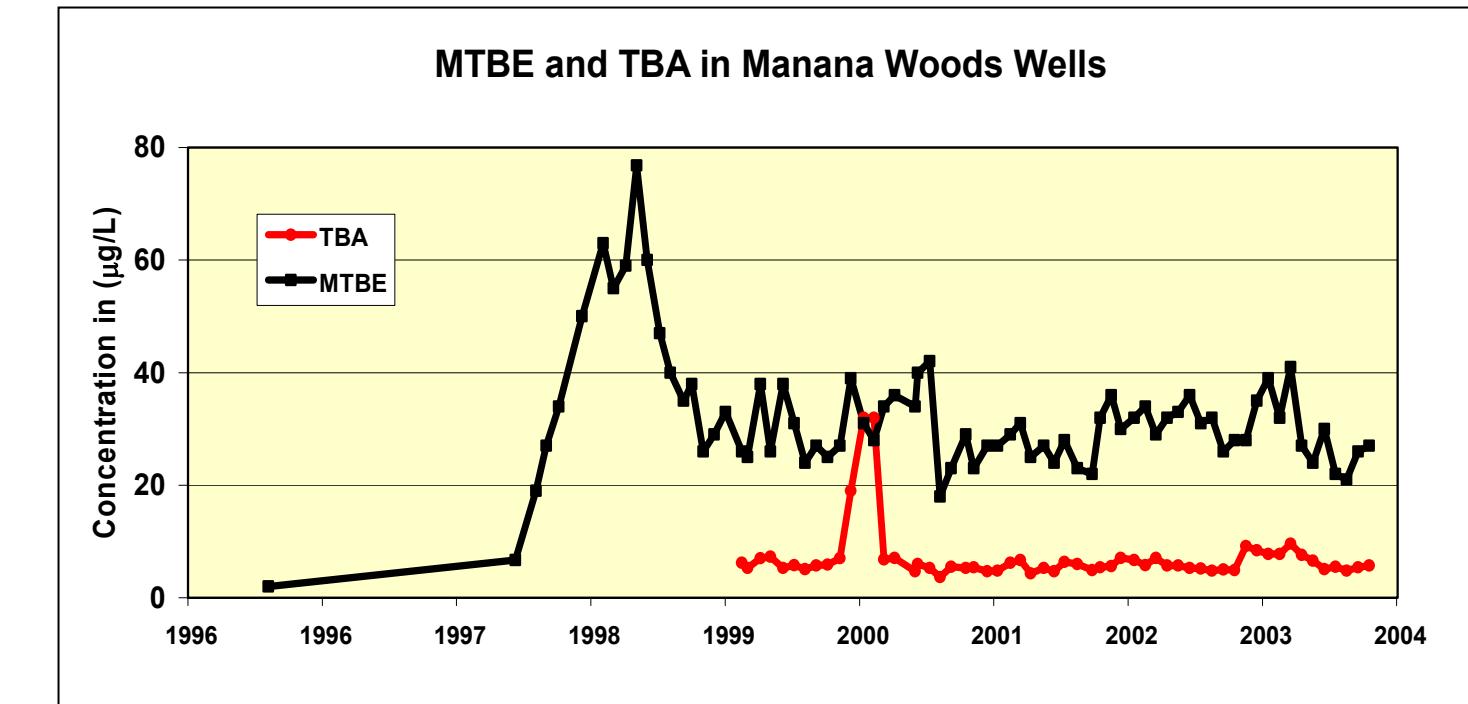
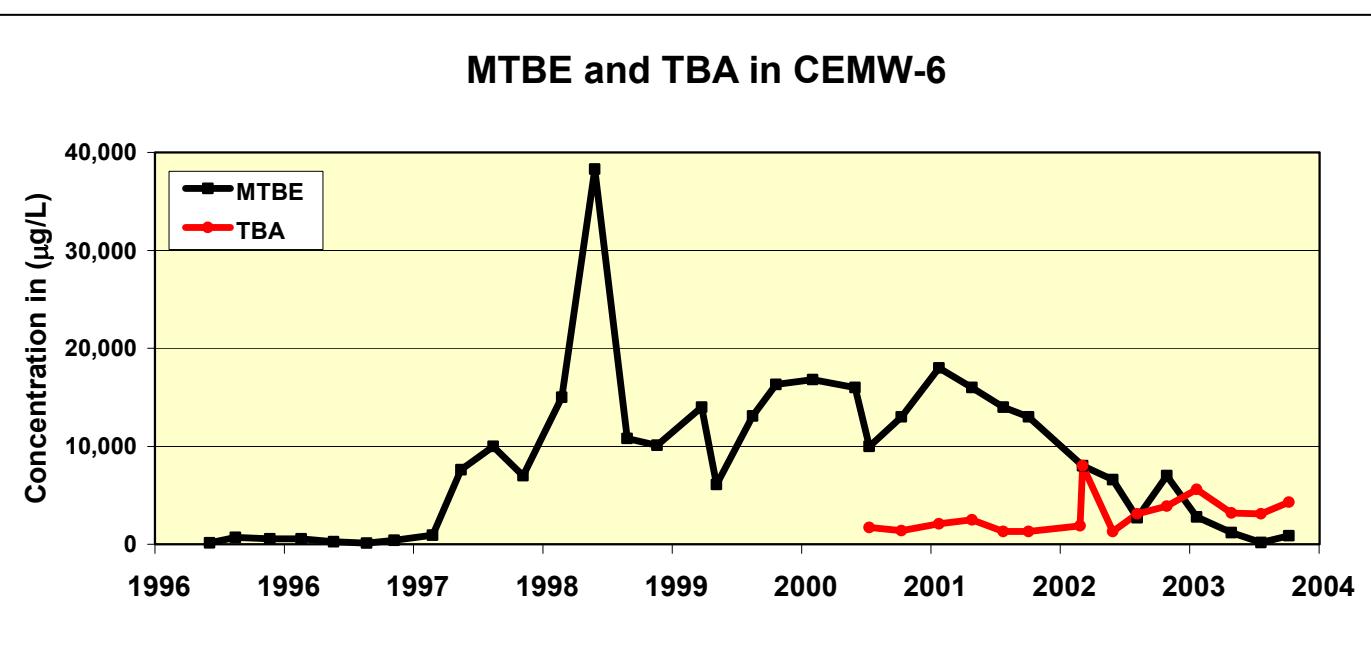
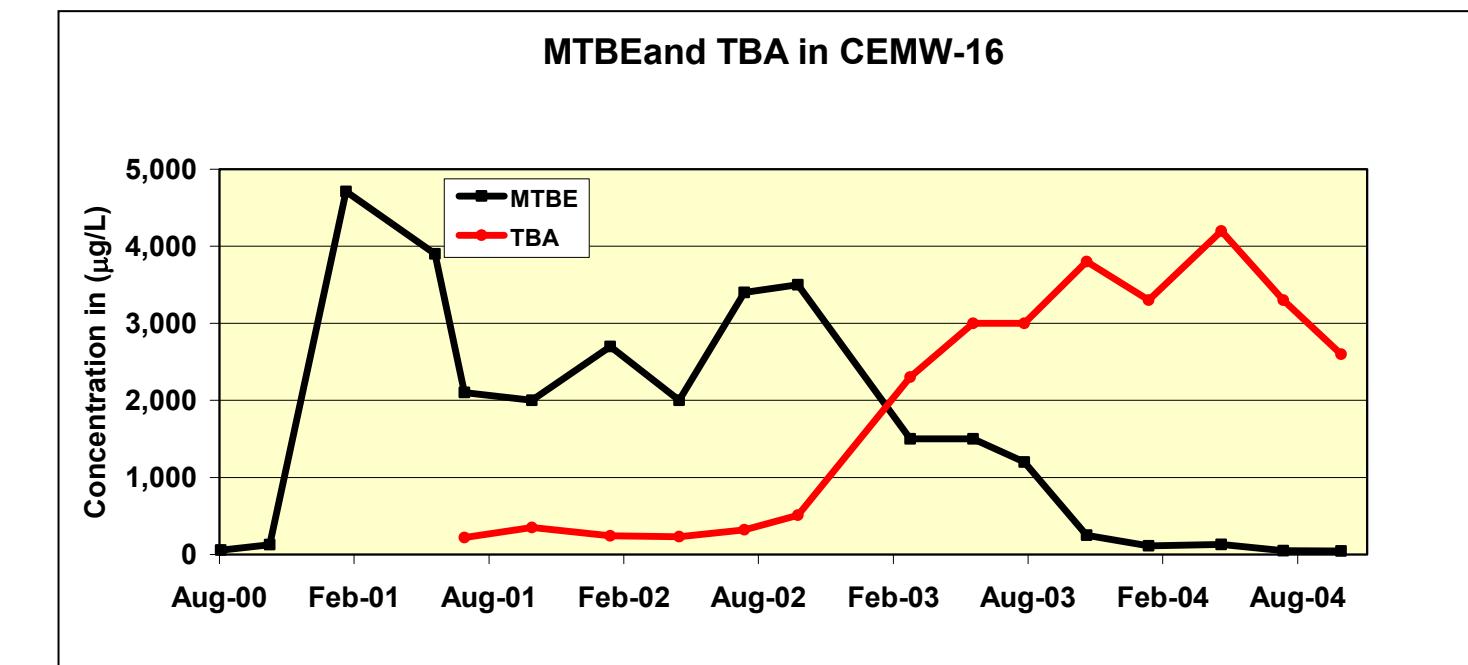
Note: CEMW-19B well is screened in the lower portion of the Santa Margarita Sandstone.
The Mañana Woods #2 Well is completed in both the Santa Margarita and Lompico Sandstone.

Note: CEMW-6 and CEMW-16 are screened in the upper portion of the Santa Margarita Formation. Concentration scales vary significantly between graphs of upper Santa Margarita wells and lower Santa Margarita wells.

Environmental Compliance Summary: Camp Evers Wells with Detections
